DEPARTMENT OF TRANSPORTATION

Quality Assurance and Source Inspection

Contract #: 04-0120F4Cty: SF/ALA Rte: 80 PM: 13.2/13.9File #: 69.28**WELDING INSPECTION REPORT****Resident Engineer:**Pursell, Gary**Address:** 333 Burma Road**City:** Oakland, CA 94607**Report No:** WIR-012704**Date Inspected:** 14-Mar-2010**Project Name:** SAS Superstructure**OSM Arrival Time:** 700**Prime Contractor:** American Bridge/Fluor Enterprises, a JV**OSM Departure Time:** 1900**Contractor:** Zhenhua Port Machinery Company, Ltd (ZPMC), Changxing Island **Location:** Shanghai, China**CWI Name:****CWI Present:****Yes No****Inspected CWI report:** **Yes No N/A****Rod Oven in Use:** **Yes No N/A****Electrode to specification:** **Yes No N/A****Weld Procedures Followed:** **Yes No N/A****Qualified Welders:** **Yes No N/A****Verified Joint Fit-up:** **Yes No N/A****Approved Drawings:** **Yes No N/A****Approved WPS:** **Yes No N/A****Delayed / Cancelled:** **Yes No N/A****Bridge No:** 34-0006**Component:** OBG Trial Assembly**Summary of Items Observed:**

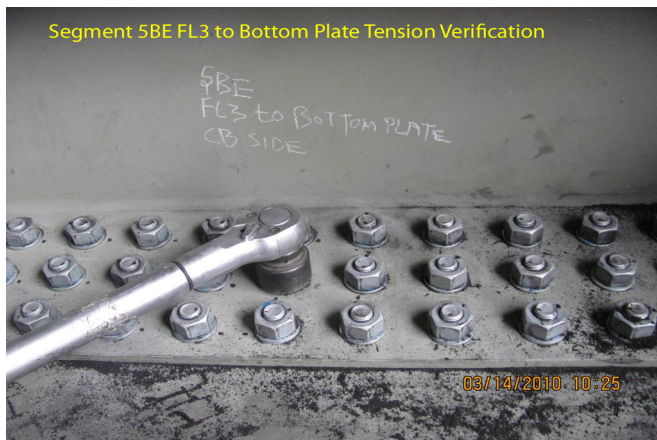
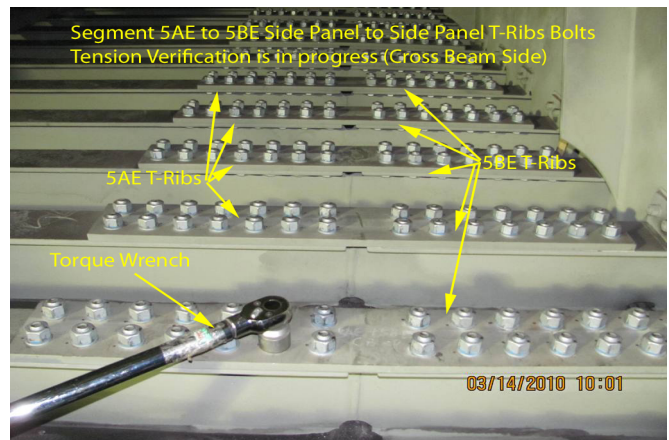
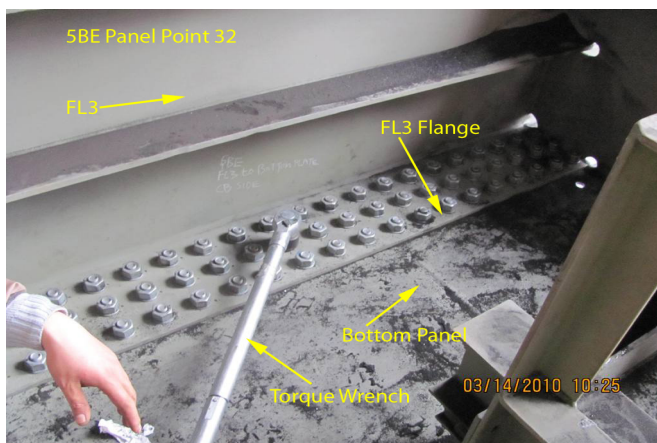
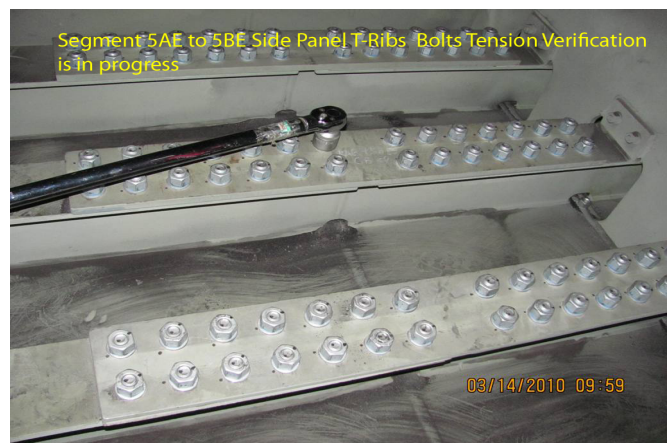
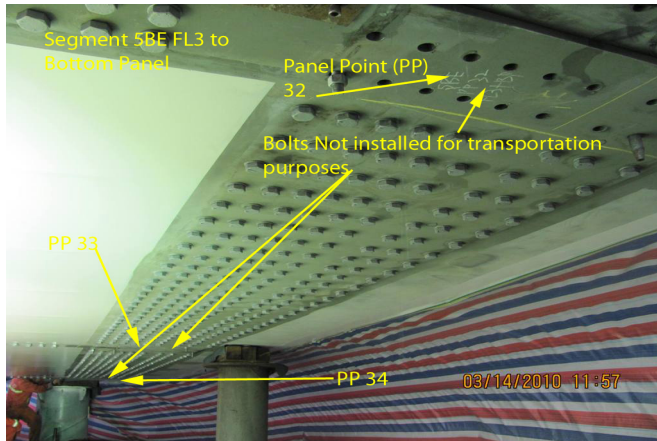
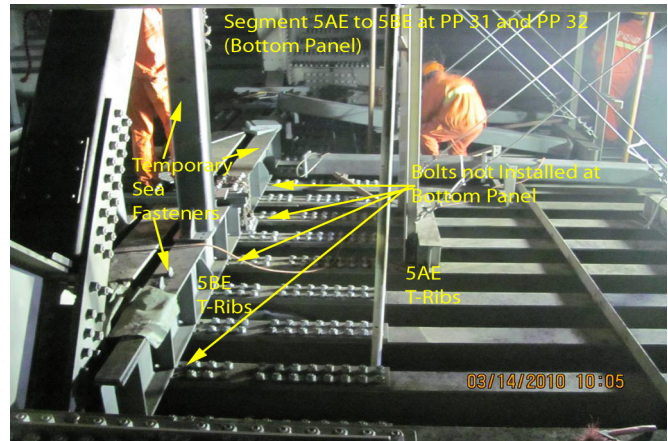
Note: Few bolts at PP 32, PP 33 and PP 34 bolts not installed due to the temporary bolts been installed. Please refer the pictures attached below for more comprehensive details.

Manual Torque wrench was been used with Sr. No. XQ2-578. The Offset measured at all the T-Ribs locations for Side Panel performed and noticed at 10th and 11th T-Rib at Side Panel Cross Beam side 5.5mm and 6.5mm offset respectively and at 18th T-Rib at Side Panel Bike Path side offset measured as 5mm and informed ZPMC QC to install 12mm extra splice plate on top of Splice plate which is existing as per RFI No. 0002004 Dated Dec 17, 2009 (numbering reference taken from Longitudinal Diaphragm towards Side Panel).

Note: Bottom Panel T-Ribs bolts tension verification not performed due the temporary sea fasteners been installed. Please refer the pictures attached below for more comprehensive details.
